April 27, 2012

Project No. D50541

SUBJ: Sutro Tower
1 La Avenzada Street
San Francisco, CA

Routine Inspection of Leg C and South Face – December, 2011
Inspection of Stack C – January, 2012

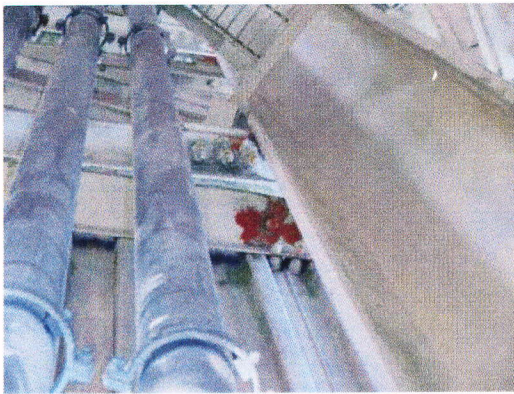
Photo 1 – PC222039
12/22/11

Observ. No.	Location / Identification			Photo No.	Inspection Comments
	Chord ¹	Horiz. Location	Item ²		
1	U	4.1	V/C	1	RF(6)
2	M	4.2	D/C	2	RF
3	L	4.2	V/C	3	RF(3)
4	U	4.2	C	4	RF on skin bracket
5	L	4.2	V/C	5	RF(4)
6	L	4.5	V/C	6	RF(2)
7	U	4.4	C	7	RF, Rust on beam flange
8	U	4.5	V/C	8	RF(2)
9	U	4.7	C	9	RF(2) and loose fastener
10	M	4.6	D/C	10	RF(2)
11	L	All	H	n/a	Rust on beam web, exterior
12	n/a	4.2	O	11, 12	Rust on door hinges
Sutro Tower				Signature: <i>Richard D</i>	Page: 1 of 1
San Francisco, CA				File:	Date: 12-22-11

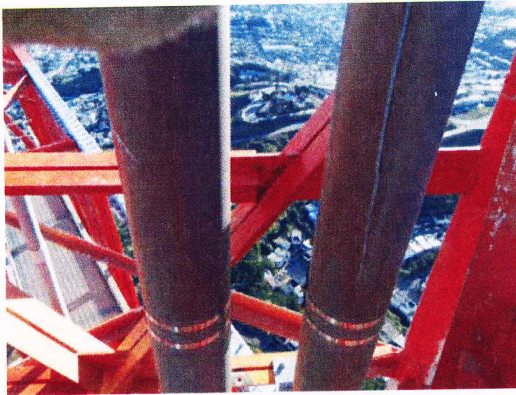
Photo 1
1/28/12

Observ. No.	Location/Identification			Photo No.	Observation Comments
	Column	Elevation	Item ¹		
1	C1-C2	6.1	D	1	RUSTY WELD
2	C2-C3	6.1	D	2	RUSTY WELD
3	C2	6.1	T	3	RUSTY WELD
4	C1	6.1	T	4	RUSTY WELD
5	C1-C2	6.18	C	5	RUSTY FASTENERS
6	C2	6.14	T	6	RUSTY WELD
7	C1	6.17	T	7	MISSING COATING
8	C2-C3	6.22	D	8	RUSTY FASTENERS
9	C2	6.24	A	9	RUSTY FASTENERS @ CHANNEL
10	C2-C3	6.24	D	10	RUSTY CONNECTION PLATE
11	C3	6.29	A	11	RUSTY APPURTENANCE PLATE
12	C3	6.33	T	12	RUSTY WELD
13	C2	6.31	D	13	RUSTY CONNECTION PLATE
14	C1	6.32	T	14	" " "
15	TOP	6.40	C	15	RUST ON FASTENERS
<p><i>A EXTERIOR FACES HAVE SEVERAL GROUPS OF FASTENERS WITH SEVERAL BOLTS/NUTS RUSTY</i></p>					
Sutro Tower				Signature: <i>R. C. [Signature]</i>	Page: 1 of 2
San Francisco, CA				File:	Date: 1-28-12
