April 27, 2012

Project No. D50541

SUBJ: Sutro Tower
1 La Avenzada Street
San Francisco, CA

Routine Inspection of Leg C and South Face – December, 2011
Inspection of Stack C – January, 2012

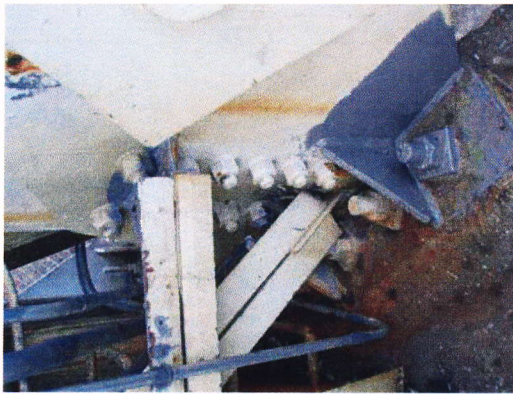
Photo 1 – PC282126
12/28/11

Observ. No.	Location / Identification			Photo No.	Inspection Comments
	Chord ¹	Horiz. Location	Item ²		
1	M	2.6-7	H/C	no photo	RF (exterior)
2	U	2.1	C	1	RF(5)
3	L	2.1	C	2	RF(5)
4	U	2.1	C	3	RF
5	M	2.2	C	4	RW
6	L	2.1	C	5	RF(2)
7	L	2.3	V/C	6	RF
8	L	2.5	C	7	RF(3)
9	M	2.6	H	8	Rust on beam flange
10	L	2.7	C	9	RF(3)
11	U	2.7	C	10	RF
12	U	2.6	C	11	Rust on skin bracket
13	L	2.7	C	12	RF on antenna bracket
14	L	2.7	O	13	Rust on antenna strut
15	U	2.7	H/V	14	Rust on beams
Sutro Tower				Signature: <i>[Signature]</i>	Page: 1 of 2
San Francisco, CA				File:	Date: 12-28-11
